MARYLAND INVENTORY OF HISTORIC BRIDGES HISTORIC BRIDGE INVENTORY MARYLAND STATE HIGHWAY ADMINISTRATION/MARYLAND HISTORICAL TRUST

MHT No. <u>SM-515</u>

SHA Bridge No. 18012 Bridge name Turner Road over Lockes Swamp Creek
LOCATION: Street/Road name and number [facility carried] MD 6 (Turner Road)
City/town Huntersville Vicinity X
County St. Mary's
This bridge projects over: Road Railway Water X Land
Ownership: State X County Municipal Other
HISTORIC STATUS: Is the bridge located within a designated historic district? Yes No X National Register-listed district National Register-determined-eligible district Locally-designated district Other
Name of district
BRIDGE TYPE: Timber Bridge: Beam Bridge: Truss -Covered Trestle Timber-And-Concrete Stone Arch Bridge Metal Truss Bridge
Movable Bridge: Swing Bascule Single Leaf Bascule Multiple Leaf Vertical Lift Retractile Pontoon
Metal Girder : Rolled Girder Concrete Encased : Plate Girder : Plate Girder Concrete Encased : Plate Girder Concrete : Plate Girder Concrete : Plate Girder : Plat
Metal Suspension
Metal Arch

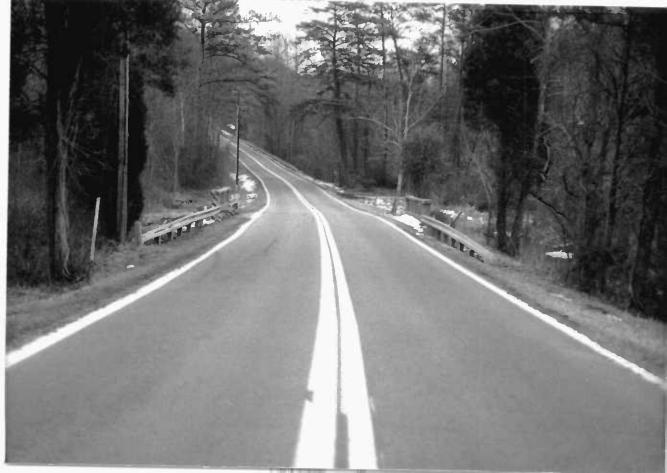
1 OF 4 SM- 515 ST MARYS COUNTY D. BHAUMIR 2-1-95 MARYLAND SHOO MD 6 OVER SWAMP CREEK LOOKING EAST ON MD 6 3RIDGE 130/2)

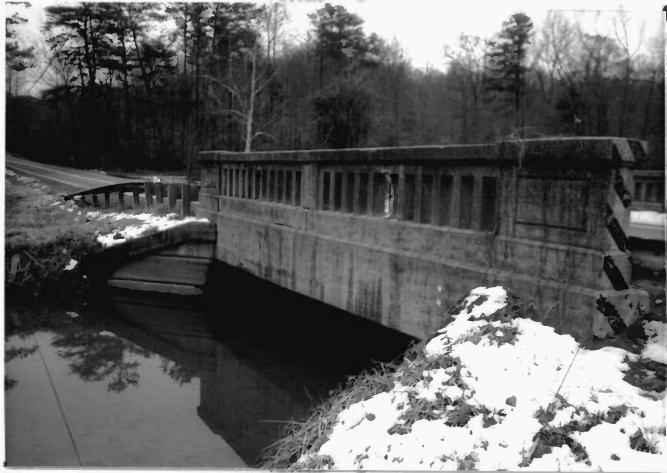
2 OF 4 SM-515 ST MARYS COUNTY O. BHAUMIK 2-1-95 5400 MARYLAND MOG OVER SWAMP CREEK LOOKING SOUTH (DOGEN STREAM RACE) (BRIDGE BOIL)

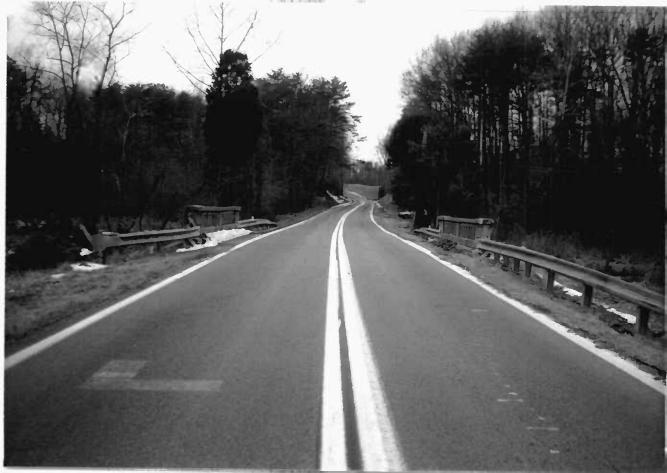
3 OF 4 SN 515 ST MARYS COUNTY D. BHAUMIK 2-1-95 MARY CAND SHPO MD 6 OVER SWAMP CREEK LOOKING WEST ON MDG (BRIDGE 130/2)

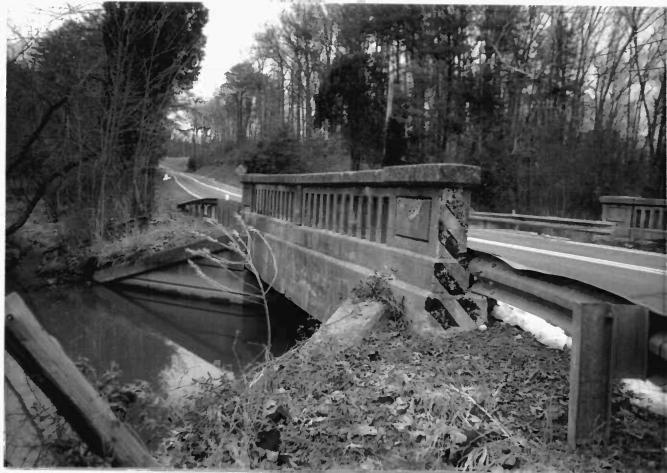
4 OF 4 SM-515 ST MARYS COUNTY D. BHAUMIK 2-1-95 SHPO MARYLAND SWAMP CREEK MD6 OVER LOOKING NORTH (UPSTREAM FACE) (BRIDGE 13012)
